FIRE PATTERNS ANALYSIS WITH LOW HEAT RELEASE RATE INITIAL FUELS

ABSTRACT

Twelve full-scale research burns into the nature of fire effects and fire patterns in compartment fires were conducted at the research facility of Eastern Kentucky University. This series of tests was an evolution of the previous eight full-scale tests performed at this facility. The purpose of this test series was to evaluate the damage caused by an initial, low heat release rate fuel and the influence on this initial damage when a secondary fuel that is substantially higher in heat release rate and total energy output was involved. Key fire effects observed and measured are reported here, along with the test parameters and variables altered throughout testing.

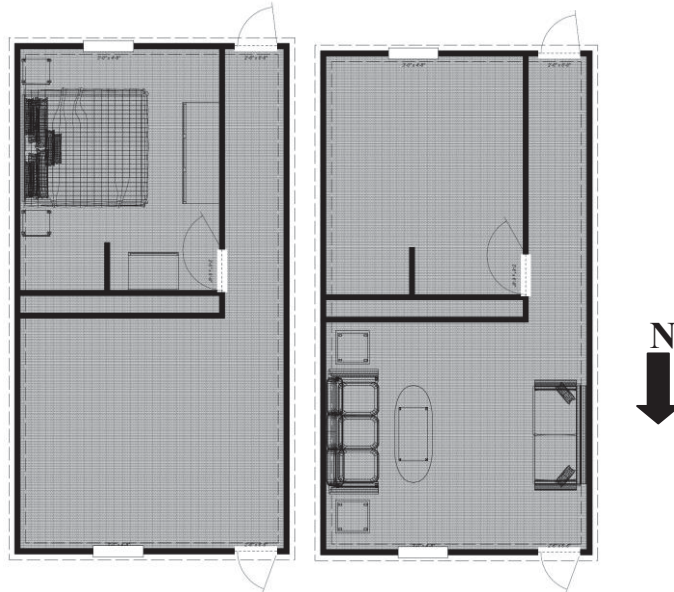
Figure 4: Fuel Layout (left) Bedroom Furniture; (right) Living Room Furniture

Experiment sets A, C, E, G, I: were furnished as typical residential bedrooms (Figure 4). The bedrooms had wall-to-wall carpeting on the floor.

Experiment sets B, D, F, H, J: were furnished as residential living rooms (Figure 4). The living room as well as the hallway had wall-to-wall carpeting on the floor.

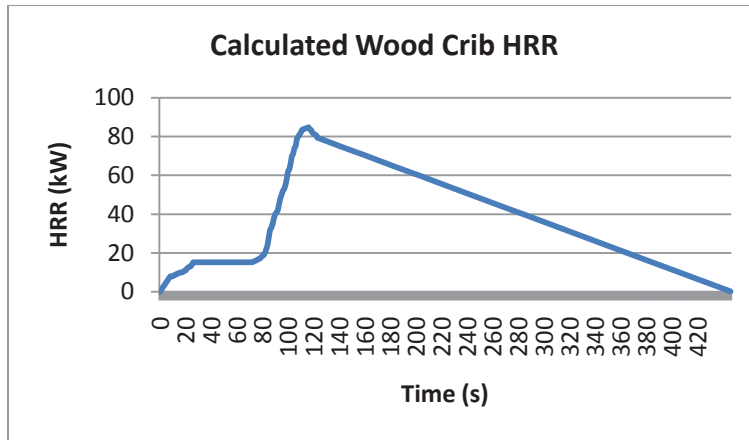
Figure 6: Estimated Heat Release Rate of Initial Fuel

While the above calculation is an estimate, it does provide the general burning regimes for the burning wood crib over the duration of the fire and provides peak heat release rates for the two regimes (approximately 15 kW and 90 kW).

However, when $t > t_o$, the mass loss rate for either the fuel surface controlled or the crib porosity controlled burning regime will be the governing rate. It is assumed for these calculations that v_p is $2.2 \times 10^{-6} b^{-0.6}$ and that the heat of combustion for the wood is held constant at 12×10^3 kJ/kg (despite the heat of combustion varying as a function of time).

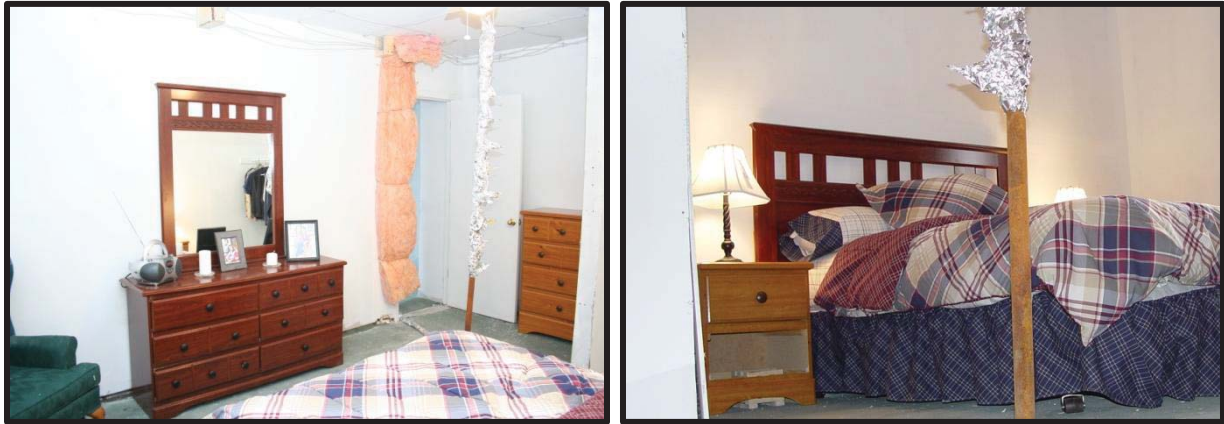
Figure 7: Pre-fire Fuel Layout

Standard bedroom, including: a queen bed with headboard, mattress, and box spring; dresser; closet area with hanging clothes; polyurethane foam wing-back chair; nightstand on each side of bed; chest of drawers; a small wood table; and two table lamps. The first fuel ignited was the wood crib placed inside the nightstand on the north side of the bed (Figure 7).

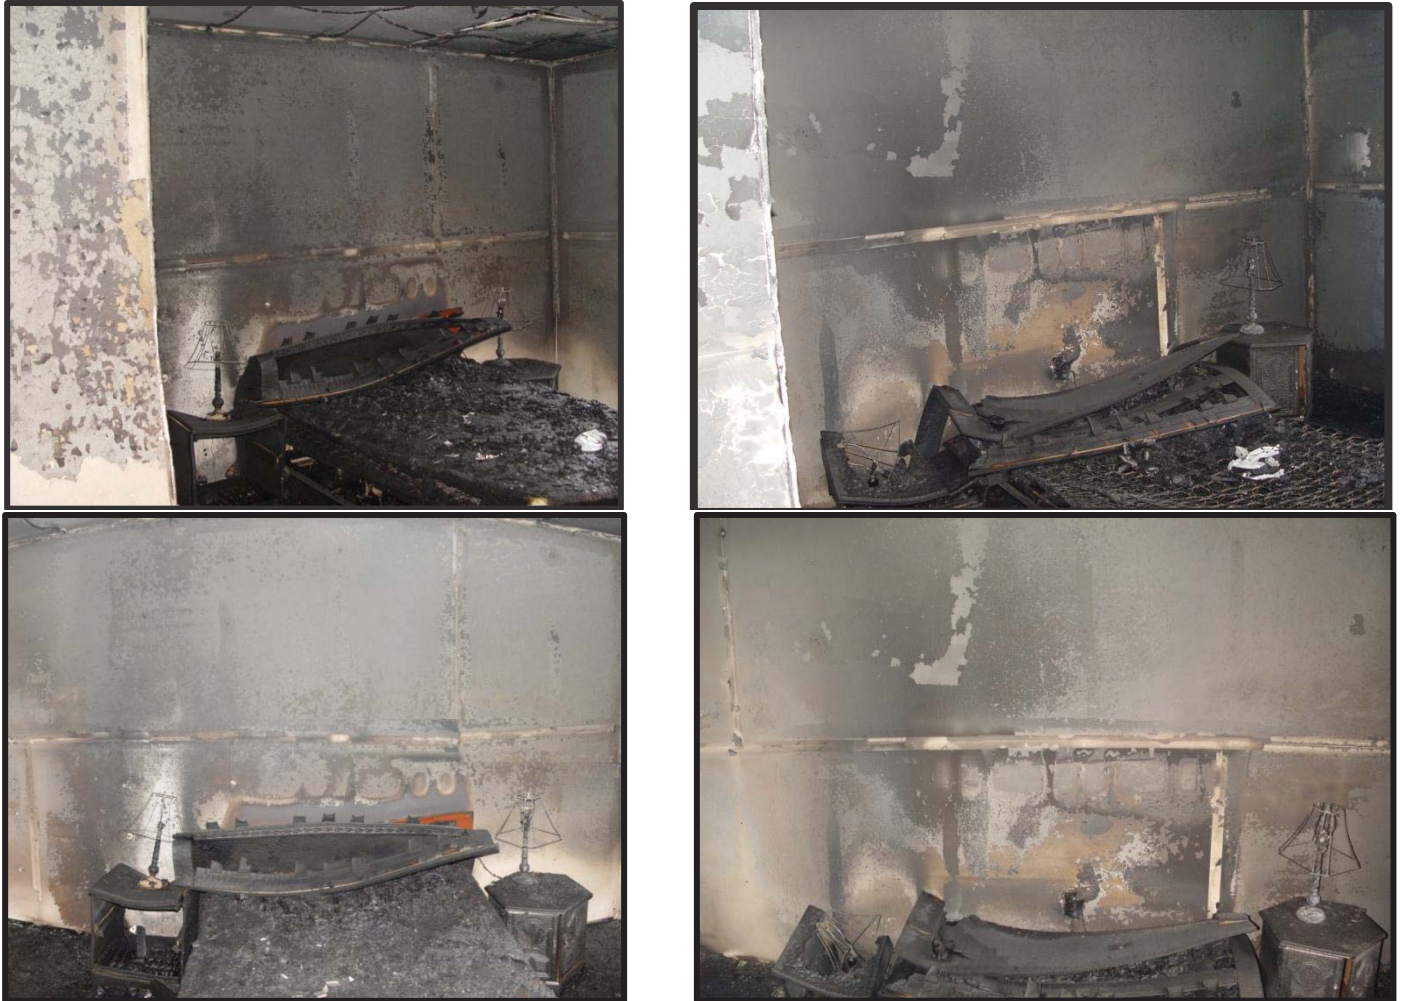
Figure 9: Post-fire Damage-Left Nightstand=Area of Origin (left) Cell 1; (right) Cell 2

Witness Surface	Key Fire Effects
East Wall	<ul style="list-style-type: none"> • Distinct clean burn located behind north (left) nightstand starting near floor level extending approximately 4 feet in height. • The protected area behind the headboard on east wall is less visible near the north end (left) due to failure of headboard left to right.
Nightstand(s)	<ul style="list-style-type: none"> • North nightstand has greater char on interior compared to its exterior • North nightstand has considerably greater loss of mass and overall damage compared to the south nightstand. • Near complete loss of mass to the interior of the north nightstand. • South nightstand has no damage interior • South nightstand has similar damage on either exterior side
Lamp(s)	<ul style="list-style-type: none"> • The north lamp had greater loss of mass. • The power cord to the left lamp had a severed arc. • The base of the north lamp protected the top of the nightstand.

<ul style="list-style-type: none"> • Greater oxidation near the head of the on north side of bed frame (cell 2)
North Wall	<ul style="list-style-type: none"> • West half of wall has greater heat exposure (charring and loss of paper). • Top half of wall has greater damage.
Chest	<ul style="list-style-type: none"> • Greater loss of mass and char to top of dresser. Greater char on the front of the chest and lesser towards back.
West Wall	<ul style="list-style-type: none"> • Protected area behind the dresser and the dresser mirror • Greater depth of calcination near south corner above chair.
Dresser	<ul style="list-style-type: none"> • Increasing line of demarcation height from front to back on both ends of the dresser • Greater overall damage, including char, at the top of the dresser and lesser at the base.
South Wall	<ul style="list-style-type: none"> • Greater calcination around window
Chair	<ul style="list-style-type: none"> • Complete loss of mass • Even charring and loss of mass over entire chair.

The tests in series E were similar in the type and location of fire effects observed and measured compared to each other (Table 2). In previous tests when the mattress was ignited directly, a distinct plume effect was present on the east wall directly above the bed for all four experiments (Gorbett, et. al., 2006). However, in these two tests, the plume effect was not similarly present, even when the majority of the mass from the mattress was consumed (Figure 9). The fire effects from the initial fuel package (wood crib) are still obvious in these two tests, evidenced by the distinct clean burn damage to the wall behind the nightstand and the directional fire effects on the mattress, headboard, and box springs all emanating from the north (left) side of the bed. Despite the presence of a high heat release rate fuel (mattress), the nightstands both show char indicative of the fire originating from inside the nightstand itself. The fire effects produced from the Series E tests provide substantial data to substantiate a fire starting in the north (left) nightstand.

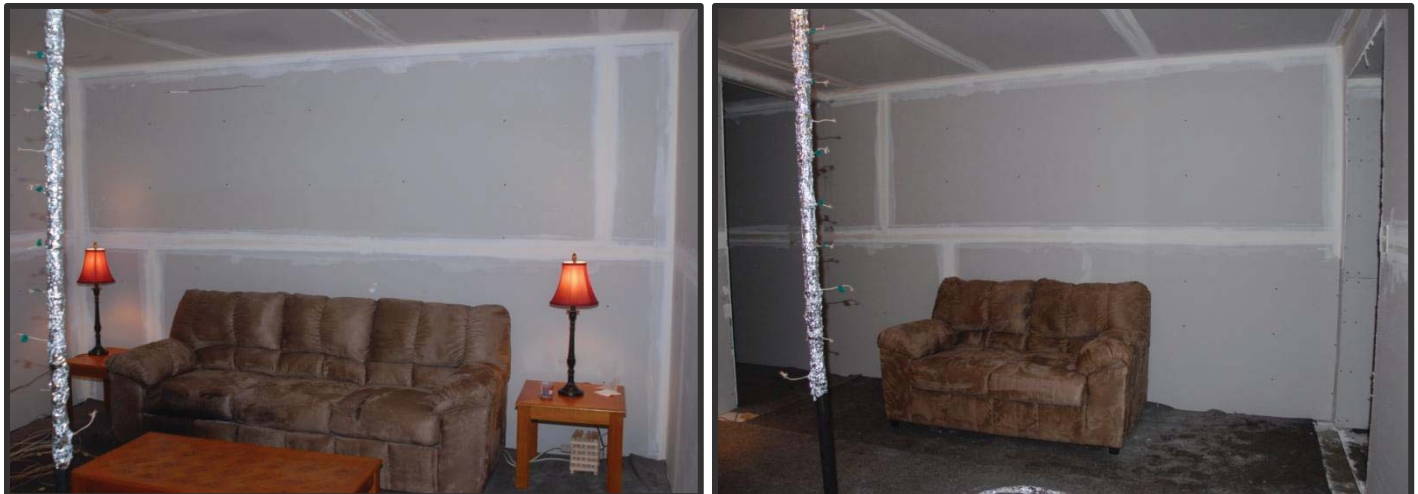
Figure 10: Pre-fire Fuel Layout

Standard living room, including: a polyurethane couch, polyurethane love seat, two end tables (one on each side of the couch), one coffee table, and lamps. The first fuel ignited was the wood crib placed underneath the end table to the south (right) of the couch (Figure 10).

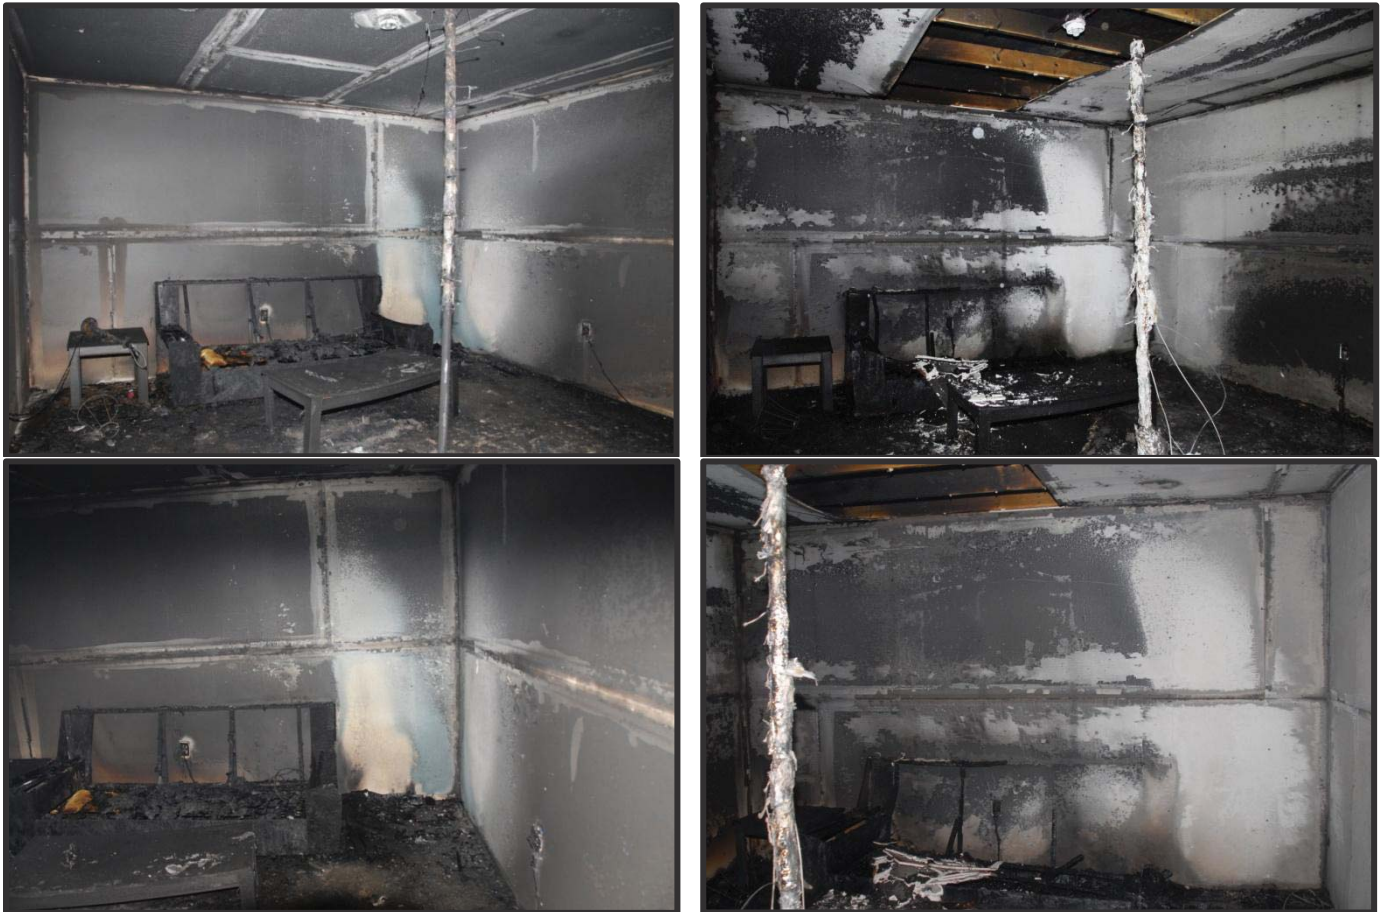
Figure 12: Post-fire Damage-Right End Table=Area of Origin (left) Cell 1; (right) Cell 2

Witness Surface	Key Fire Effects
East Wall	<ul style="list-style-type: none"> • Distinct clean burn located in southeast corner starting along base of wall extending to the ceiling. Clean burn starts in the corner and moves outward approximately 2-3 feet to the north.
End table(s)	<ul style="list-style-type: none"> • South end table complete loss of mass. • North end table is still present with moderate charring over entire surface, except lack of damage found underneath table.
Couch	<ul style="list-style-type: none"> • Greater charring along south end of couch. • Loss of mass greater at south end of couch, including foam and wood frame. • Wood kickboards for the couch have visible and measureable greater depth of char near south

end and lesser moving towards the north.
Coffee Table	<ul style="list-style-type: none"> • Greater depth of charring on southeast table leg and trim of table • Table top has greater charring along southeast corner.
North Wall	<ul style="list-style-type: none"> • Cell 1-soot deposit over the entire wall • Cell 2-areas of clean burn uniformly over the entire wall • Areas of greater clean burn located near ceiling and near the window and doorway
West Wall	<ul style="list-style-type: none"> • Increasing line of demarcation height starting at floor level near door with greatest damage near door and above the north end (right) of the love seat. Pattern represents the flow of air over the loveseat • Clean burn located in NW corner near door that extends to above north end (right) of the love seat.
Love seat	<ul style="list-style-type: none"> • Greater loss of mass on north side (right) nearest doorway. • Greater char on the north side (right).

South Wall	<ul style="list-style-type: none"> • Increasing line of demarcation between clean burn area and soot deposited areas coming from the SE corner extending from floor to ceiling.
Ceiling	<ul style="list-style-type: none"> • Cell 1-Nearly uniform soot deposited over the entire area, except in SE corner an area of clean burn exists. • Cell 2-Clean burn relatively uniform over entire area. Greatest depth of calcination is found in the SE corner with lesser damage in the hallway.

Series F tests were similar in the type and location of fire effects observed and measured compared to each other (Table 3). The fire effects from the initial fuel package (wood crib) are still obvious in these two tests, evidenced by the distinct clean burn damage in the SE corner and the directional fire effects observed and measured on the fuel items surrounding this area (i.e. couch, tables).

In previous tests, the couch was ignited in the center and resulted in a plume shaped clean burn damage directly above the couch on the east wall (Gorbett, et. al, 2006). Series F tests did not replicate a similar damage along the east wall above the couch. The fire effects located on the west wall near the love seat and door were almost identical to the previous tests. The fire effects produced from the Series F tests provide substantial data to substantiate a fire starting in the corner.

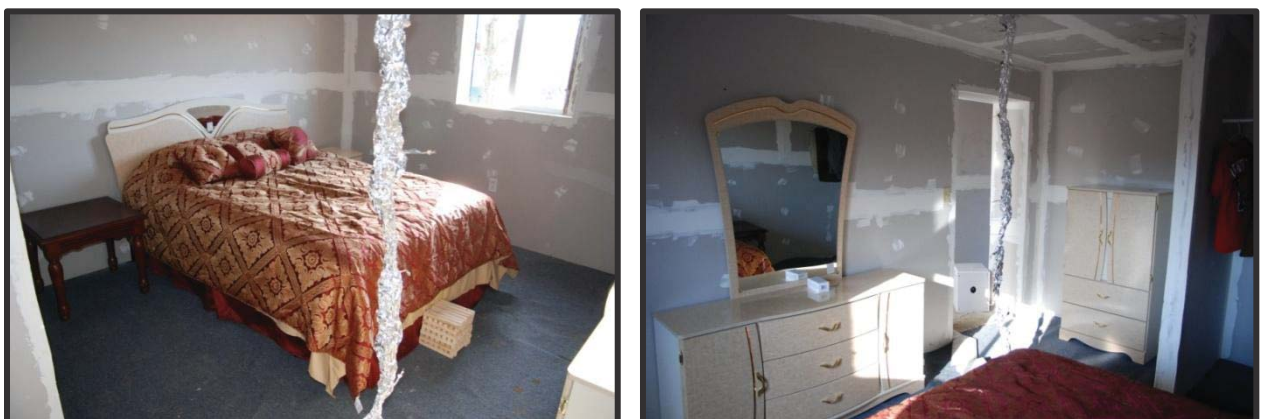
Figure 13: Pre-fire Fuel Layout

Standard bedroom, including: a queen bed with headboard, mattress, and box spring; dresser; closet area with hanging clothes. Additionally, two night stands were placed next to the head of the bed (one on each side of the bed). The first fuel ignited was a wood crib placed in the center at the foot of the bed (Figure 13).

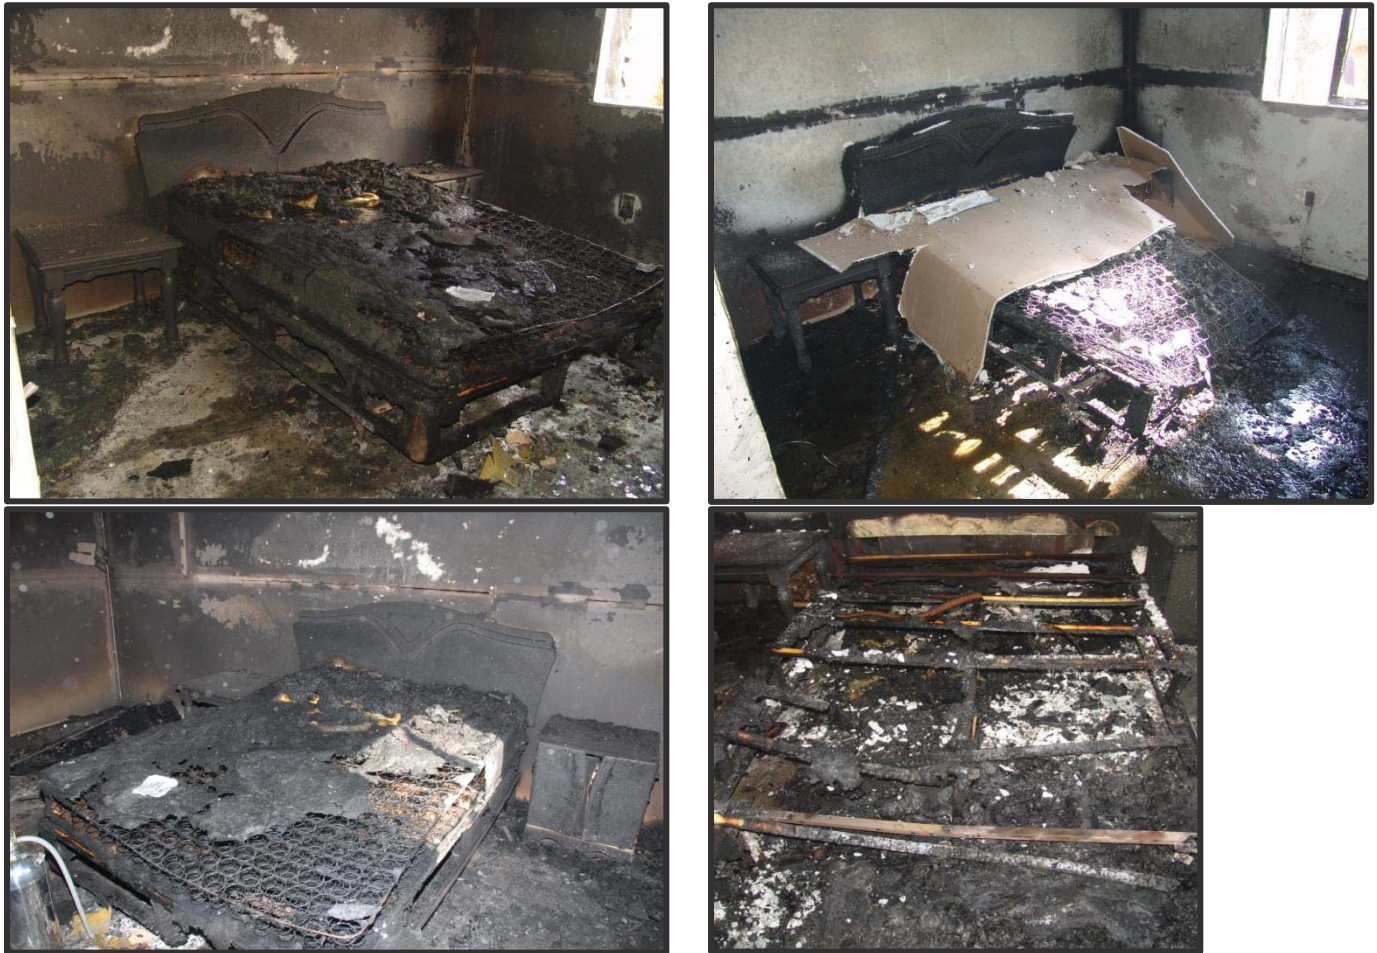
Figure 15: Post-Fire Damage - Foot of bed=Area of Origin (left) Cell 1; (right) Cell 2 (note: drywall from ceiling failed)

Witness Surface	Key Fire Effects
East Wall	<ul style="list-style-type: none"> The protected area behind the headboard on east wall is even. Cell 1-Clean burn uniformly over entire area above a 2 ft elevation, except in the corner and the closet where soot is deposited only. Cell 2-Soot deposited uniformly over entire area.
Nightstand(s)	<ul style="list-style-type: none"> Mostly uniform charring over top and legs. Greatest char was consistently found on front (west) trim and table top.
Bed	<ul style="list-style-type: none"> Cell 1-Complete loss of mass to polyurethane foam mattress and bedding.

<ul style="list-style-type: none"> • Cell 2-Complete loss of mass to the southwest corner of mattress and bedding. • Complete loss of mass of wood box frame at foot of bed. • Greater charring to wood box frame near the foot of the bed with lesser moving towards the head of the bed. • Cell 1-Loss of tensile strength to springs and collapse of springs at foot of bed. • Even char across entire headboard.
North Wall	<ul style="list-style-type: none"> • Lowest damage near doorway: cell 1-soot deposition; cell 2-burning off of craft paper • Uniform line of demarcation approximately 2ft elevation above floor; cell 1-soot deposition; cell 2: craft paper burned off and greater heating
Chest	<ul style="list-style-type: none"> • Greater char on west (left) side compared to east (right) side • Greater to lesser char from top to bottom • Increasing line of demarcation height starting at the front (south) face moving to back

West Wall	<ul style="list-style-type: none"> • Uniform protected area where mirror once stood. • Cell 1-Soot uniformly distributed along wall. Soot and heat damage found in SW corner. • Cell 2-Greatest depth of calcination near door and in southwest corner. Area of clean burn located at floor level in SW corner.
Dresser	<ul style="list-style-type: none"> • Greater char from top down on front of dresser • Char found along base trim from center to the south (left) end. • Slightly greater char to south (left) of dresser • Loss of mass/tensile strength of mirror frame • Greater damage found to south side (left) compared to north (right). • Increasing line of demarcation height starting at front face moving back
South Wall	<ul style="list-style-type: none"> • Predominately clean burn extending out from window in cell 1; Cell 2 predominantly soot deposited on the wall

Series G tests were similar in the type and location of fire effects observed and measured between the two, despite the difference in the duration of burning (Table 4). Moving the initial fuel away from a boundary surface (i.e. wall) to the base of a large fuel package was expected to cause the obscuration of the initial fire effects.

Cell 1 did not burn for as long of a duration as Cell 2. Due to this, the fire effects that remained were easily determined to have emanated from the foot of the bed. Cell 2, on the other hand, was significantly more involved. The fire effects on all of the walls were similar to those that were witnessed in previous tests where the fire originate on the bed, especially the plume generated pattern found on the east wall above the bed. However, the damage to the mattress, box spring, headboard, and dresser were considerably different from those found in the previous tests. The loss of tensile strength and collapse of the mattress spring at the foot of the bed, the loss of mass to the foot of the box spring, and the low level damage to the base of the dresser were not witnessed in the previous tests.

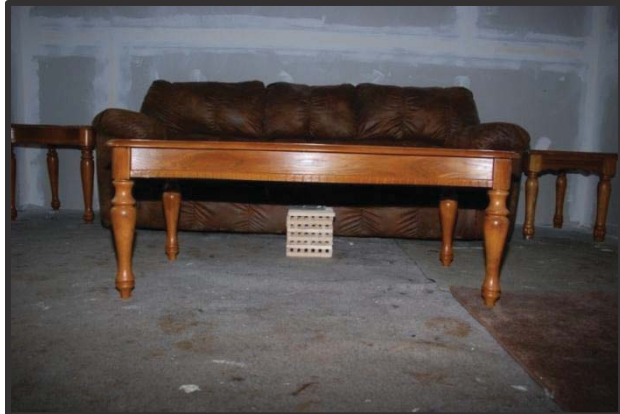
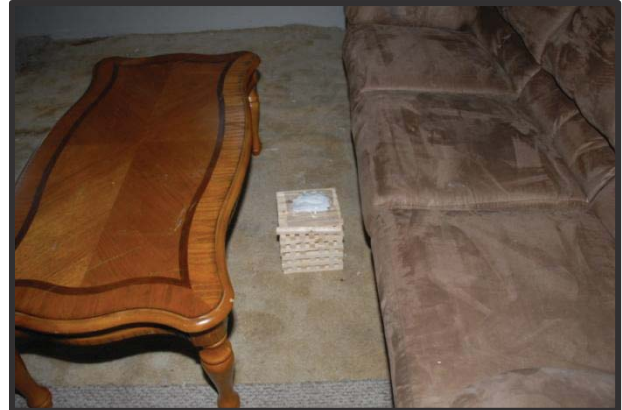
Figure 16: Pre-fire Fuel Layout

Standard living room, including: a polyurethane couch, polyurethane love seat, and two end tables (one on each side of the couch). The first fuel ignited was a wood crib placed centered to the front of the couch, between the couch and the coffee table (Figure 16).

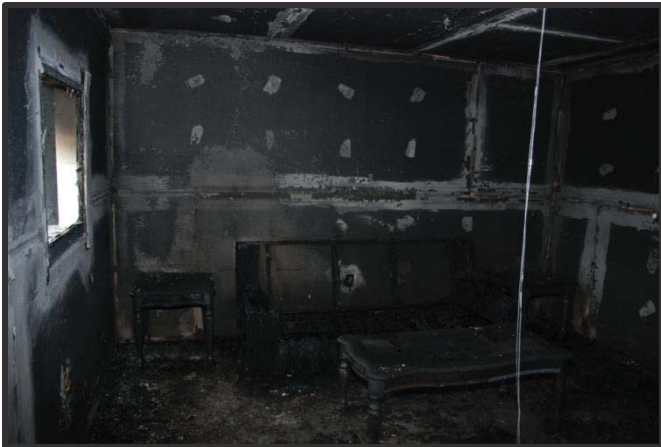
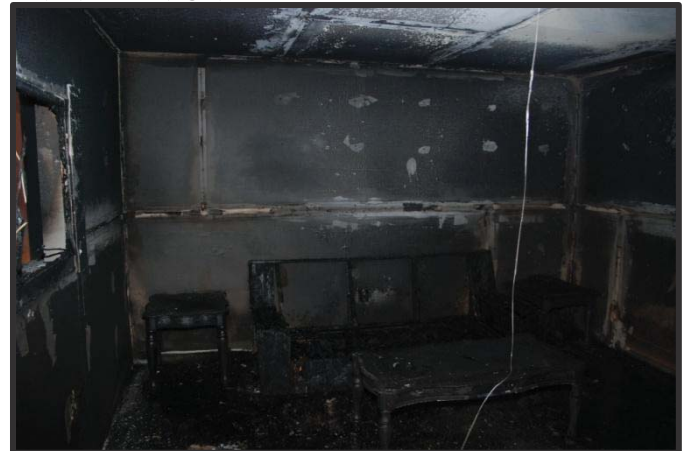
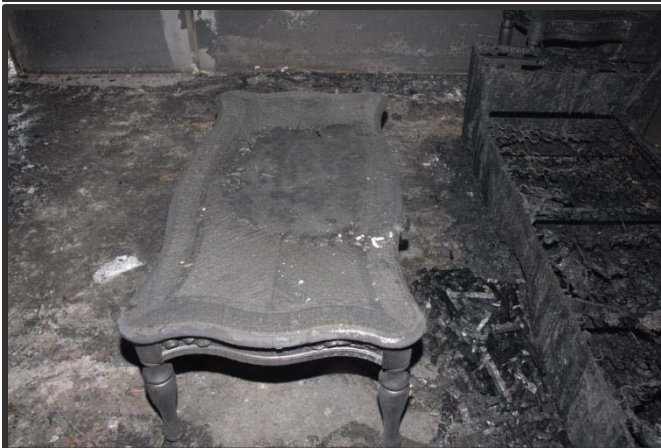
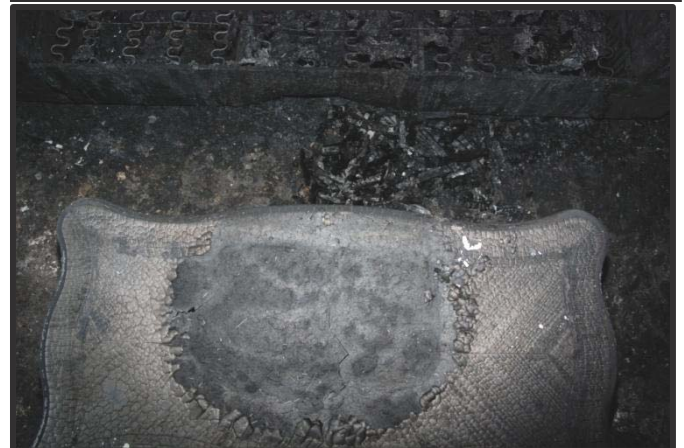
Figure 18: Post-fire Damage (left) Cell 1; (right) Cell 2

Witness Surface	Key Fire Effects
East Wall	<ul style="list-style-type: none"> • Even soot deposits with slightly greater damage to the north (left) above couch.
End table(s)	<ul style="list-style-type: none"> • Generally uniform charring. • Greater char from couch side into the end tables • North (left) end table received greater damage.
Couch	<ul style="list-style-type: none"> • Complete loss of mass of polyurethane foam from seat cushions • Uniform char along wood frame with greatest loss of mass to wood frame being in the center kickboard.
Coffee Table	<ul style="list-style-type: none"> • Pronounced radial pattern on top and underside of coffee table. • Significant damage to underside. • Greatest char found on interior table legs, except NW leg had significant damage to exterior facing doorway. • Greater char of trim on east side in the center.
North Wall	<ul style="list-style-type: none"> • Soot Deposited evenly along wall with craft paper nearly burned away between window and door • Clean burn only found directly around window and door.

West Wall	<ul style="list-style-type: none"> • Increasing line of demarcation height starting at floor level near door with greatest damage near door and above the north end (right) of the love seat. Pattern represents the flow of air over the loveseat • Clean burn located in NW corner near door that extends to above north end (right) of the love seat.
Love Seat	<ul style="list-style-type: none"> • Greater loss of mass on north side (right) nearest doorway. • Greater char on the north side (right).
South Wall	<ul style="list-style-type: none"> • Cell 1-Greater damage to east half of wall lesser damage moving towards hallway. • Cell 2-Clean burn with increasing line of demarcation height extending from ~3ft above floor starting at hallway moving east. (Figure 19)
Ceiling	<ul style="list-style-type: none"> • Cell 1-uniform soot deposit over entire area. • Cell 2-uniform clean burn from center of room extending to the west wall and hallway. East half area soot deposited.

Series H tests were similar in the type and location of fire effects observed and measured compared to each other, except the effects on the south wall (Table 5). This series of tests moved the initial fuel item away from a boundary surface (i.e. wall) to the base of a large fuel package. This was expected to cause the obscuration of the initial fire effects. In the previous tests, where the sofa was ignited directly, there was a distinct fire plume damage above the sofa on the east wall. However, neither of these tests had a similar fire effect noted. The fire effects clearly emanate from the front, center of the couch in both tests, evidenced by the pronounced radial pattern on the coffee table, the loss of mass from the center of sofa, and the directional fire effects observed and measured on the coffee table. The fire effects located on the west wall near the love seat and door were almost identical to the previous tests and test series F.

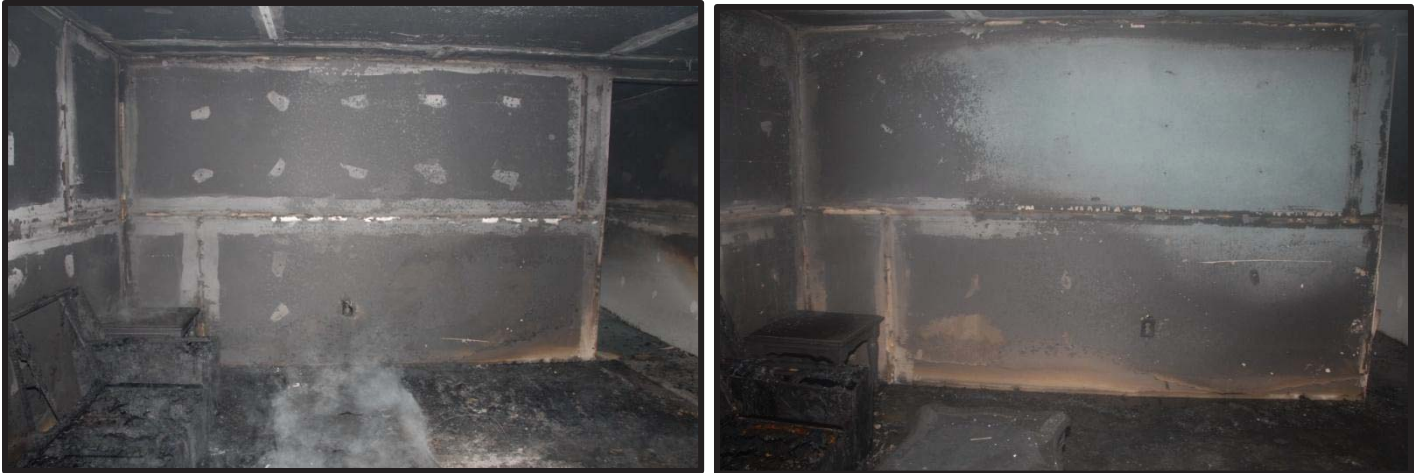
Figure 19: South wall (left) cell 1; (right) cell 2

The one notable difference in reproducibility of the fire effects was the damage noted on the south wall. The south wall in cell 1 had almost a uniform soot deposition and heat treatment along its entire width, while the south wall in cell 2 has a significant amount of clean burn along the west half of the wall (Figure 19). It is hypothesized that this damage was due to better combustion occurring in this area, most like due to the airflow in this area from the adjacent open doorway and hallway.

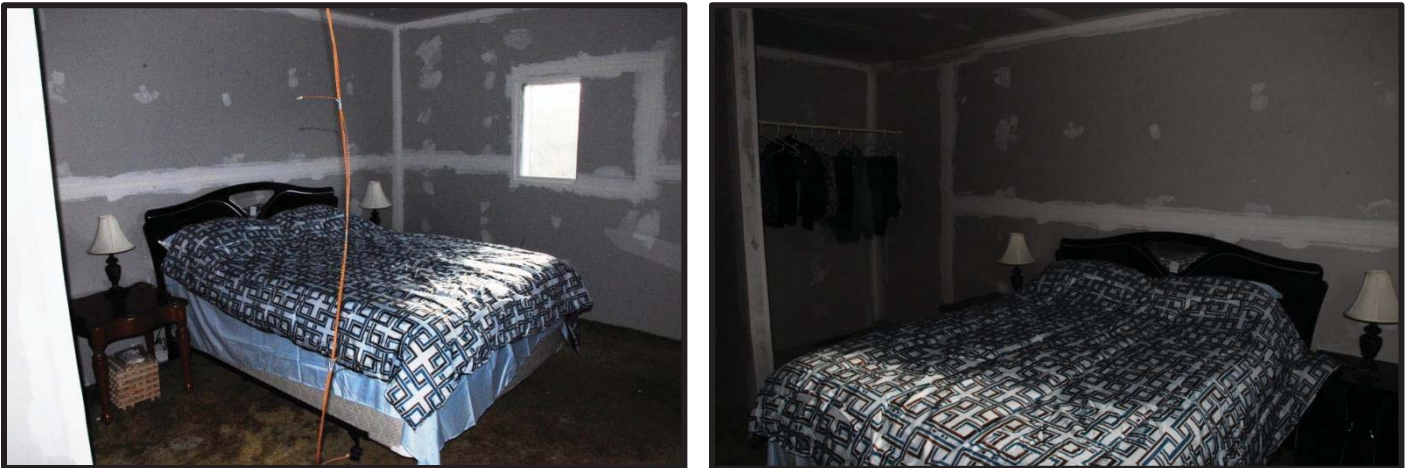
Figure 20: Pre-fire Fuel Location

Standard bedroom, including: a queen bed with headboard, mattress, and box spring; dresser; closet area with hanging clothes; polyurethane foam wing-back chair; nightstand on each side of bed; chest of drawers; a small wood table; and two table lamps. The first fuel ignited was the wood crib placed inside the nightstand on the north side of the bed. The window in this series was closed (Figure 20).

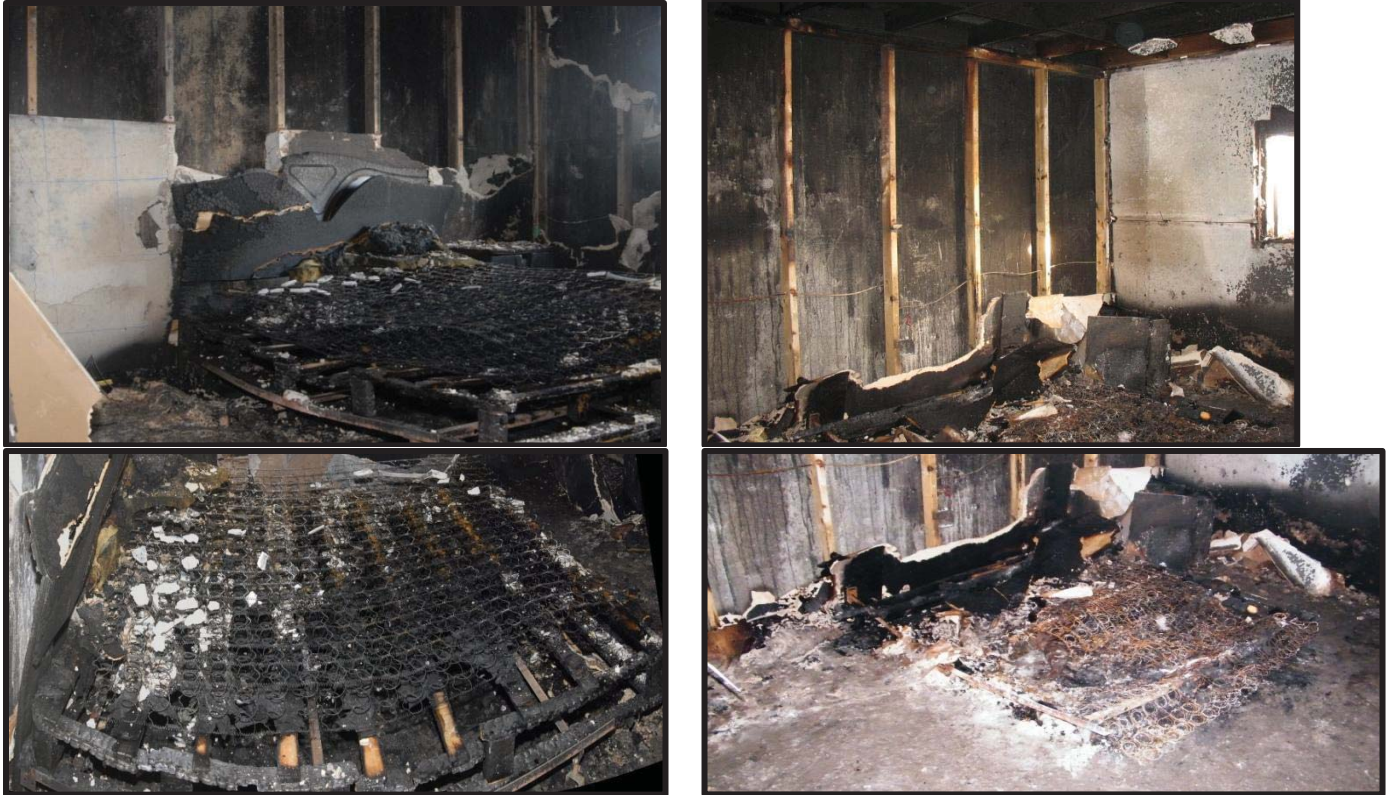
Figure 22: Post-fire Damage (left) Cell 1; (right) Cell 2

Witness Surface	Key Fire Effects
East wall	<p>Cell 1-</p> <ul style="list-style-type: none"> • Loss of drywall above 4 ft; Significant clean burn north of bed behind (left) nightstand • Protected area behind headboard • Char only to 2x4 wood header north of bed directly above nightstand <p>Cell 2-</p> <ul style="list-style-type: none"> • Loss of drywall over entire area, except protected area behind remaining headboard and south end behind nightstand. • Electrical conductor discolored only to north of bed directly above nightstand and severed in this area. • Only charring on 2x4 stud is found directly behind nightstand.
Nightstand(s)	<ul style="list-style-type: none"> • Complete loss of mass to north (left) night stand, south (right) nightstand still present.
Bed	<p>Cell 1-</p> <ul style="list-style-type: none"> • Loss of mass almost complete of the polyurethane foam, except some still present in southeast corner (near head of bed on right side) • Headboard has greater char and loss of mass to north (left) side. • Deformation of metal bed frame along north (left) side. • Loss of mass and greater charring along north (left) side of box springs. <p>Cell 2-</p> <ul style="list-style-type: none"> • Complete loss of mass of the foam, box spring, and almost all of the headboard. • Metal bed frame (all slats) greater oxidation to north (left) side. • Headboard greater loss of mass to north (left) side.

North Wall	<p>Cell 1-</p> <ul style="list-style-type: none"> • Clean burn ~4ft in elevation from floor uniformly across entire wall; Craft paper charred, but still present 4 ft to ceiling.

Cell 2- <ul style="list-style-type: none"> • Clean burn over entire area. Soot deposition in NW corner; Protected area behind chest
Chest	Cell 1- <ul style="list-style-type: none"> • Greater char at top and lesser at the base. • Increasing line of demarcation height starting at the front (south) face moving to back Cell 2- <ul style="list-style-type: none"> • Greater damage right to left. • Complete loss of integrity with almost even charring from top to base.
West Wall	Cell 1- <ul style="list-style-type: none"> • Uniform protected area where mirror once stood. Cell 2- <ul style="list-style-type: none"> • Lowest clean burn near door; Uniform damage to craft paper consumed and clean burn above 3 ft elevation.
Dresser	Cell 1- <ul style="list-style-type: none"> • Greater loss of mass (to laminate) of wood facia from north side (right) moving to the south side (left) • Protected area behind mirror • Increasing line of demarcation height starting at front face moving back Cell 2- <ul style="list-style-type: none"> • Loss of both doors. Protected area behind mirror gone; Greater char top down

South Wall	Cell 1- <ul style="list-style-type: none"> • Suppression damage in SE corner; Loss of craft paper total east half, lesser towards west wall. Cell 2- <ul style="list-style-type: none"> • Clean burn and depth of calcination greatest in SE corner and around window.
Ceiling	Cell 2- <ul style="list-style-type: none"> • Depth of char greatest to north side of bed lesser moving outward.

Series I tests had similar fire effects observed and measured compared to each other (Table 6). The fire was allowed to burn for a longer duration compared to other tests. Even though, the destruction in these tests were severe, the evolution of the fire effects were still evident and provided directional fire effects to arrive to the north side (left) of the bed. The fire effects, included oxidation of the metal bed frame, charring and loss of mass to the headboard, and the localized damage to the wood studs and joists beneath the drywall found in the area of origin.

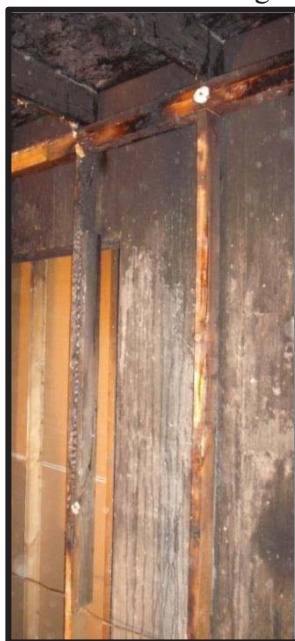
Figure 23: Cell 2 Wood Stud charred behind left nightstand
