FULL-SCALE ROOM BURN PATTERN STUDY

ABSTRACT

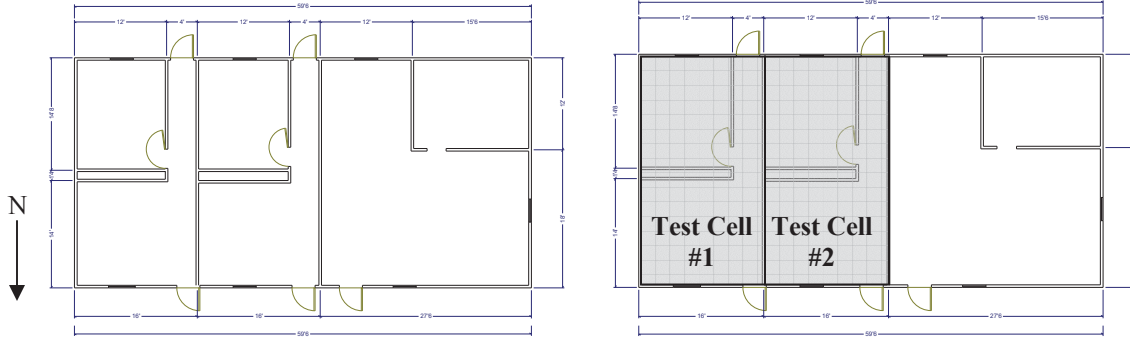
Figure 1 (left) layout of EKU test burn building; Figure 2 (right) location of test cells

The test facility used for all these recent experiment sets was the Eastern Kentucky University, Fire and Safety Engineering and Technology Program's test burn building, located on the EKU campus in Richmond, Kentucky. This structure is a specially constructed, single story building with overall dimensions of approximately 18.9 m x 9.75 m (62 feet x 32 feet). It incorporates six interconnected burn rooms and two hallways all with 8" reinforced concrete walls and roof. Individual test cells can be configured into various shapes and sizes by isolating individual spaces with gypsum wallboard partitions (see Figure 1).

The test cells for this research project encompassed the east half of the facility configured into two identical 4.88 m by 9.75 m (16' by 32') cells (Figure 2). The cells were constructed of 8" poured, reinforced concrete walls, which were lined with 2x6 joists and gypsum wallboard (See Figure 2). All dimensions are approximated.

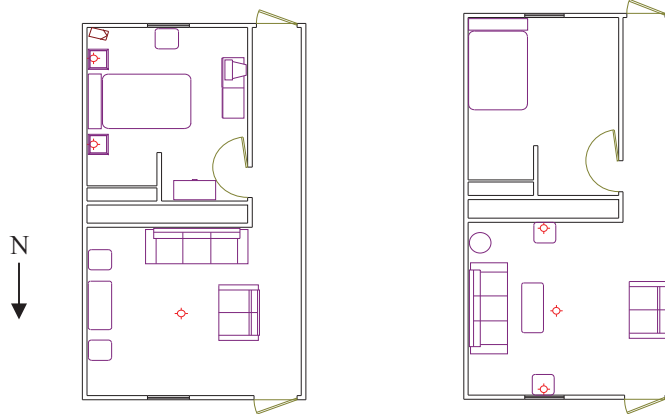
**Figure 3 (left) Furniture Layout for Experiment Set "A" & "C";
Figure 4 (right) furniture layout for Experiment Set "B"**

Experiment sets "A" and "C": Experiment sets "A" and "C" (conducted in March 2005 and March 2006) were roughly identical in the layout and types of furniture (Figure 3). The rooms were furnished as typical residential bedrooms and living rooms. The contents of each bedroom included a bed, chest, two lamps, end tables, two nightstands, television (not included in experiment set "C"), clothing and a dresser with an attached mirror. The bedrooms had wall-to-wall carpeting on the floor. The contents of each living room included a couch, loveseat, coffee table, two end tables, and television. The living room as well as the hallway had wall-to-wall carpeting on the floor.

Experiment set "B": Experiment set "B" (conducted in November 2005) was furnished as a residential living room. The living rooms consisted of a couch, loveseat, three end tables, two lamps and a coffee table. The living room as well as the hallway had wall-to-wall carpeting on the floor. The bedroom consisted of a single mattress with bedding material (Figure 4).

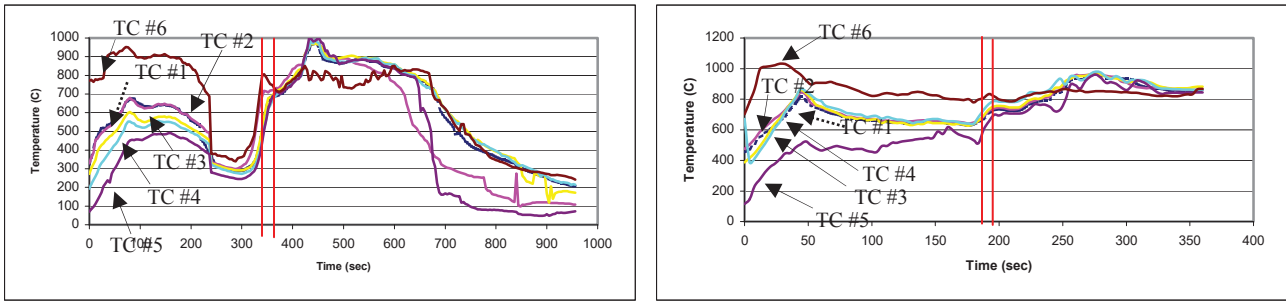
Figures 6 & 7 – Experiment Set “A” Thermocouple Data: (left)-Cell #1 (exp. 1); (right)-Cell #2 (exp. 2)

The temperatures measured by the thermocouple tree located in the bedroom of each experiment are shown in Figures 6 and 7. In cell #1 (experiment #1), the technical indicator of 600°C (1112°F) in the upper layer for flashover was achieved at approximately 330s (seconds). The duration of the post-flashover/fully involved stage of the fire, the time between flashover and suppression, for experiment #1 was 360 s. In cell #2 (experiment #2), the technical indicator for flashover of 600°C (1112°F) in the upper layer was achieved at approximately 190s. The duration of the post-flashover/fully involved stage of the fire for experiment #2 was 200s. Figure 5 illustrates a timeline for each experiment.

The ventilation conditions for the experiments were expected to differ slightly due to the different locations of the rooms within the test burn building. The differences in ventilation are also suggested by the differences in the temperature growth profiles between experiments #1 and #2. In experiment #1, prior flashover, at 230s a substantial uniform decrease in temperature for all thermocouples was recorded. However, in experiment #2, only a minor decrease in temperature was recorded for all thermocouples just prior to flashover.

A possible reason for the dramatic decrease in temperatures seen in experiment #1 and the resulting differences between the two temperature growth profiles is that the fire in experiment #1 became ventilation-controlled early on during the growth of the fire. This resulted in a decrease in temperature and a subsequent increase in time to flashover. Once sufficient oxygen concentrations returned, the fire quickly grew to transition through flashover conditions and into full-room involvement.

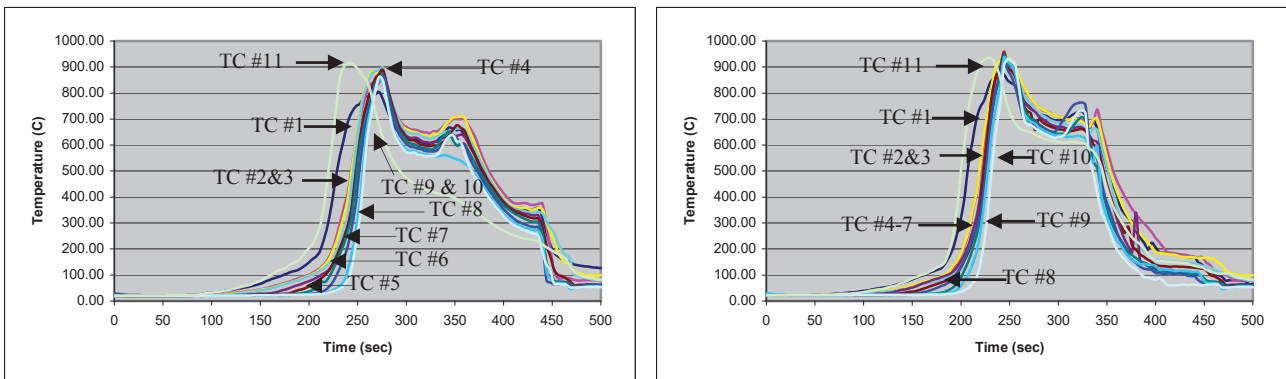
Figures 9 & 10 – Experiment Set “B” Thermocouple Data: (left)-Cell #1 (exp. 3); (right)-Cell #2 (exp. 4)

The temperatures measured by the thermocouple tree located in the living room of each experiment are shown in Figures 9 and 10. In cell #1 (experiment #3) the technical indicator for flashover of 600°C (1112°F) in the upper layer was achieved at approximately 236s (seconds). Also, in experiment #3, the duration of the post-flashover/fully involved stage of the fire was 124s. In cell #2 (experiment #4) the technical indicator for flashover of 600°C (1112°F) in the upper layer was achieved at approximately 212s. Also, in experiment #4, the duration of the post-flashover/fully involved stage of the fire was 120s. The temperature growth profiles from experiments #3 and #4 are almost identical. Figure 8 illustrates a timeline for each experiment.

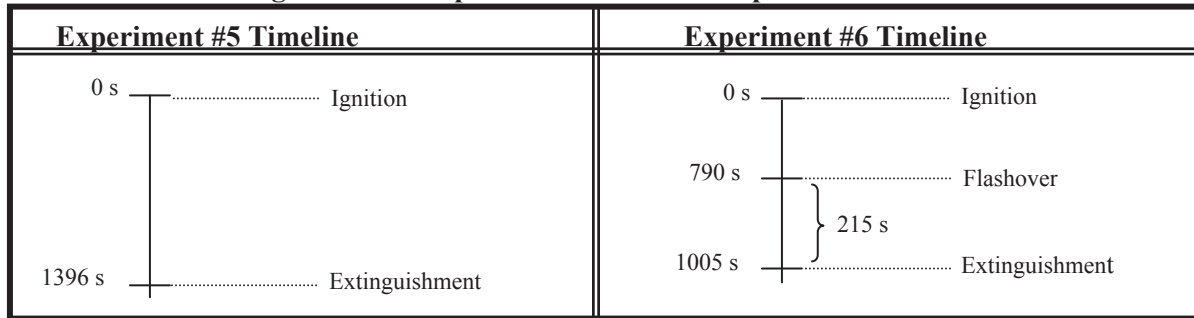
Figure 11 – Comparison of Timelines Experiment Set “C”

room involvement did not occur. This was evident from the radiometer readings (figure 14), as well as the post-fire inspection of the furnishings (Figures 34, 38, 42 and 46). In cell #2 (experiment #6), the technical indicators for flashover of 600°C (1112°F) in the upper layer and radiant flux of 20kW/m² at the floor were achieved at 790s (Figure 15). The duration of the post-flashover/fully involved stage of the fire for experiment #6 was 215s. Figure 11 illustrates a timeline for each experiment.

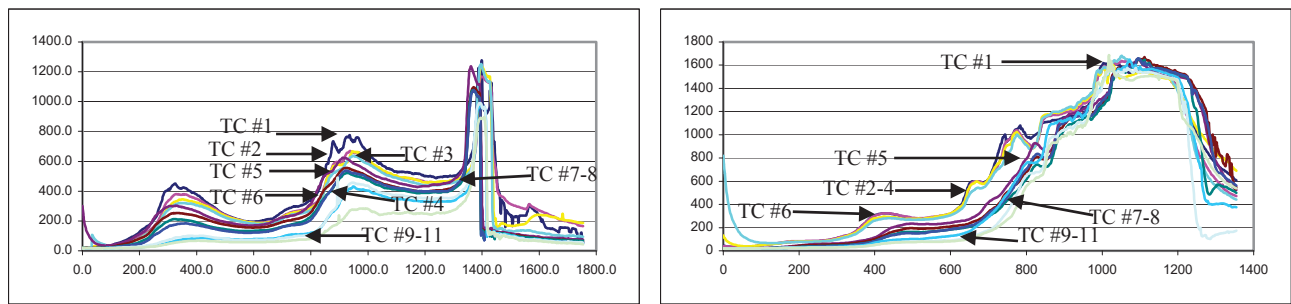
Figures 12 & 13 – Experiment Set “C” Thermocouple Data: (left)-Cell #1 (exp. 5); (right)-Cell #2 (exp. 6)

The test in cell #1 (experiment #5) was stopped early due to hazardous weather conditions creating an unsafe work environment. The temperatures measured by the thermocouple tree located in the bedroom of each experiment are shown in Figures 12 and 13. In experiment #5, the technical indicator for flashover of 600°C (1112°F) in the upper layer was achieved at approximately 1396s (seconds). However, the full transition of flashover into full-

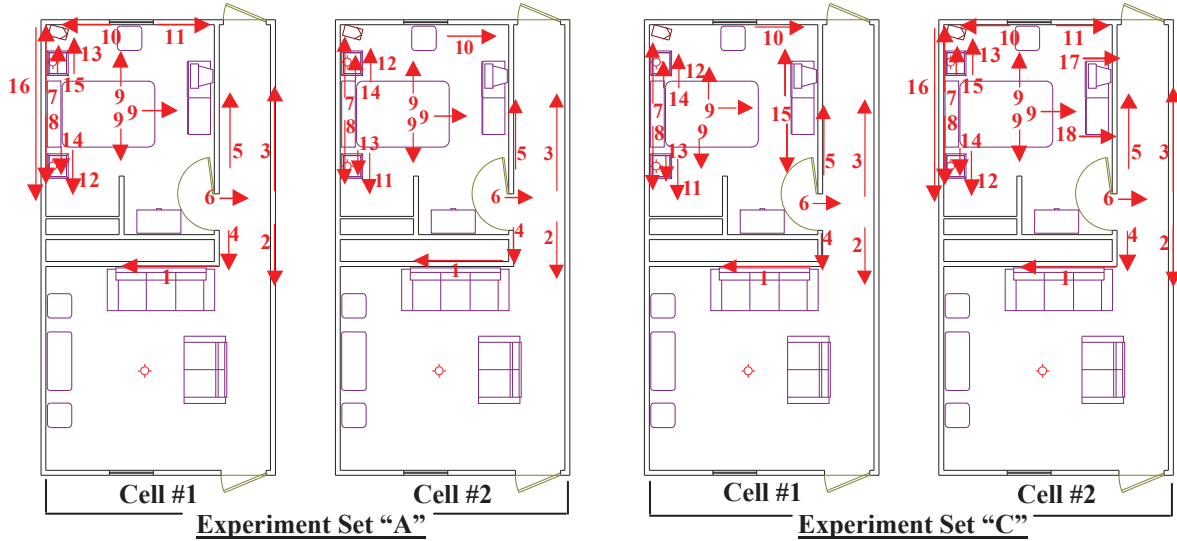
Figures 16-19 – Comparison of Heat and Flame Vector Diagrams
(left to right) Experiment Set “A”: Cell #1; Cell #2; Experiment Set “C”: Cell #1; Cell #2

Heat and Flame Vector Analysis: Each experiment was individually analyzed for all identifiable patterns. A heat and flame vector (arrow) was drawn on the respective diagram for each pattern to represent the direction of movement (fire spread). Experiment sets “A” and “C” were identical in furniture layout, and therefore, have been placed side-by-side for comparison purposes of their respective heat and flame vector diagrams (Figures 16-19). Experiment set “B” heat and flame vector diagrams are shown in Figures 20 and 21.

The Heat and Flame Vector diagrams for experiment sets “A” and “C” (experiments 1, 2, 5 and 6) demonstrate consistency. In fact, the first nine vectors for all four experiments show remarkable resemblance to each other and form the basis for the reliability of utilizing patterns and heat and flame vector diagrams for the accurate identification of an area of origin. Experiment set “B” (experiments 3 and 4) demonstrates even stronger consistency in vector analysis. Every pattern from experiment #3 was reproduced in experiment #4.

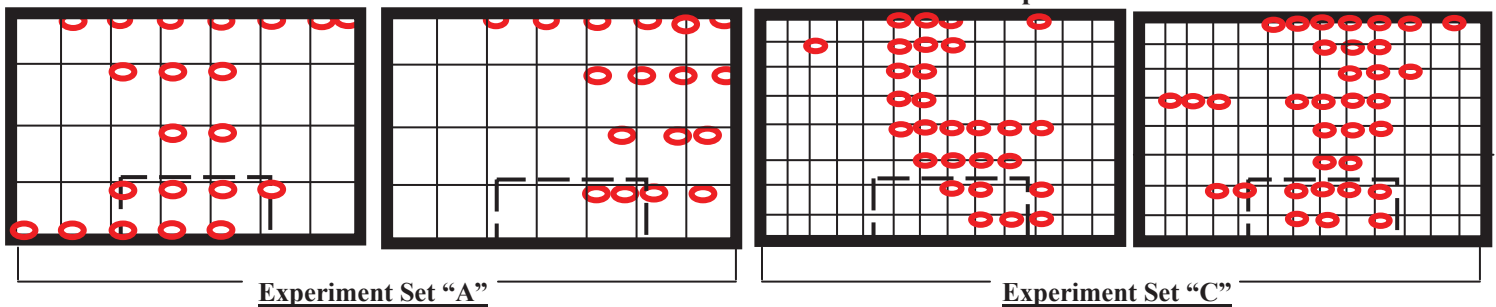
**Figures 22-25 – Comparison of Depth of Calcination Elevation (East Wall) Diagrams
(left to right) Experiment Set “A”: Cell #1; Cell #2; Experiment Set “C”: Cell #1; Cell #2
Circles indicate a measurement of 1.5 mm or deeper**

Depth of Calcination: Depth of calcination measurements were taken and recorded utilizing a depth gauge on a two-foot by two-foot grid for experiment set “A” and a one-foot by one-foot grid for experiment sets “B” and “C”. These depths of calcination readings have been transferred onto depth of calcination diagrams for additional pattern comparisons (Figures 22 and 27). Experiment sets “A” and “C” are illustrated by an elevation diagram of the east bedroom wall with the outline of the bed illustrated by a dashed line (Figures 22-25). A circle indicates a measurement of 1.5 mm or deeper, thus displaying a pattern of similar total heating. Experiment set “B” is demonstrated by an elevation diagram of the east wall with the outline of the couch illustrated by a dashed line (Figures 26 & 27). A circle indicates a measurement of 0.7 mm or deeper, thus displaying a pattern of similar total heating.

A review of the depth of calcination diagrams with the post-fire photographs illustrates similarities between the visible patterns that remain and the measured intensity patterns in and on the calcined wallboard. Though there are slight differences in the resemblance of the diagrams from different tests, a general consistency is demonstrated between all of them.

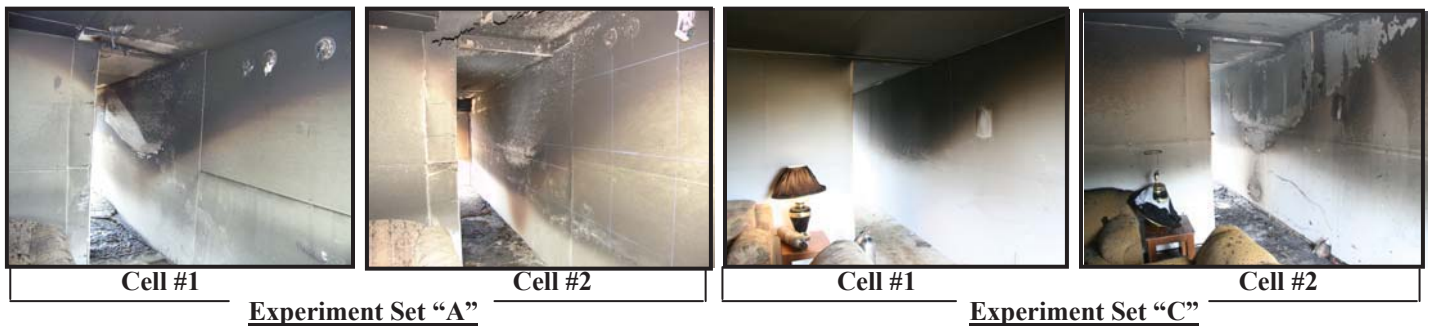
Figure 28-31 – Hallway (left to right) Exp. Set “A”: Cell #1, Cell #2; Exp. Set “C”: Cell #1, Cell #2

Similar truncated cone patterns (i.e. boundary patterns) were witnessed on the walls in all four experiments. The patterns remaining on the hallway walls demonstrate consistency. All four experiments produced a “U-shaped” pattern opposite the doorway on the hallway wall. The only difference that existed was the pattern in experiments #2 and #6 had a lower vertex than experiments #1 and #5 (Figures 28-31).

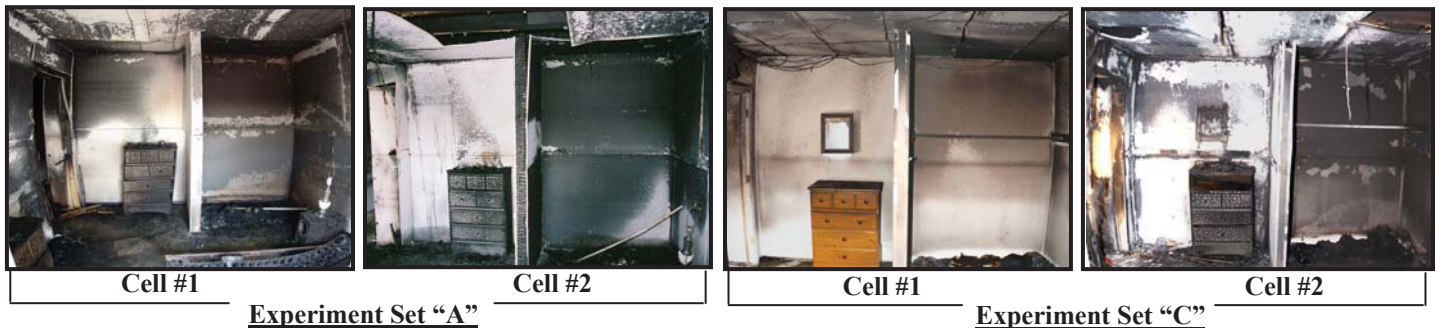
Figure 32-35 – North Wall (left to right) Exp. Set “A”: Cell #1, Cell #2; Exp. Set “C”: Cell #1, Cell #2

Along the north wall, a similar area of clean burn located on the west side above the chest was witnessed for the three experiments that progressed to full-room involvement (Figures 32, 33 and 35). Also, similar lines of demarcation are witnessed for all four experiments (Figures 32-35).

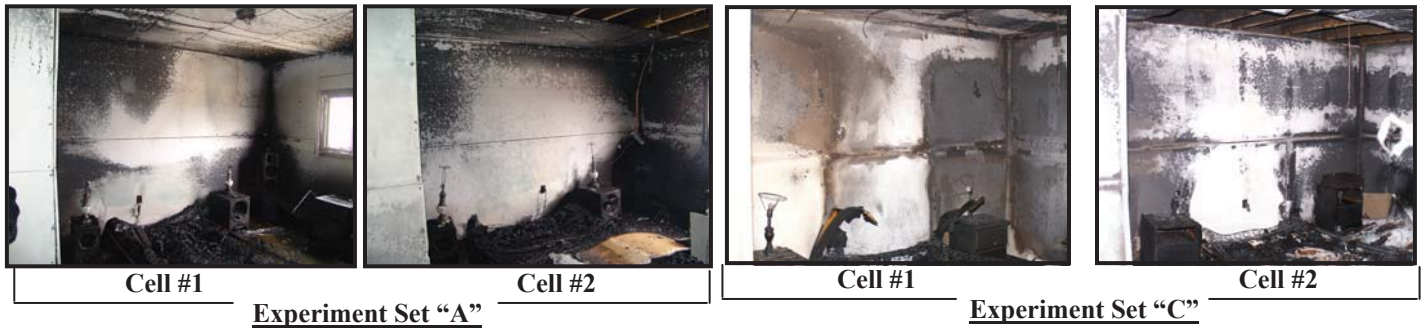
Figure 36-39 – East Wall (left to right) Exp. Set “A”: Cell #1, Cell #2; Exp. Set “C”: Cell #1, Cell #2

A consistency of the plume pattern on the east wall directly above the bed was witnessed for all four experiments. Additionally, a similar elongation of the plume pattern toward the south wall, where the window was located, was witnessed in all four experiments (Figures 36-39).

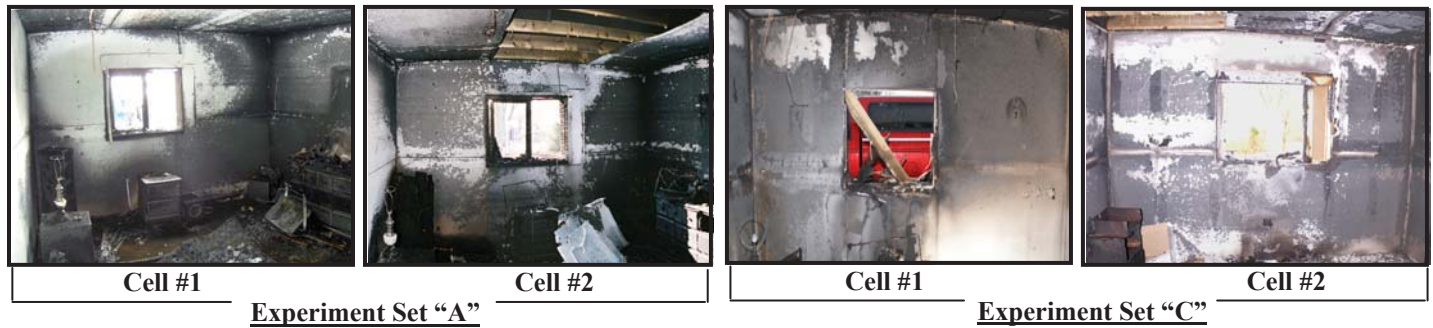
Figure 40-43 – South Wall (left to right) Exp. Set “A”: Cell #1, Cell #2; Exp. Set “C”: Cell #1, Cell #2

The plume pattern on the east wall also extended onto the south wall with an area of greater damage (clean burn) for all four experiments witnessed near the ceiling of each wall and the window. Additionally, a “U-Shaped” pattern was witnessed along the south wall for all four experiments that corresponded with the truncated cone of the plume originating from the bed (Figures 40-43).

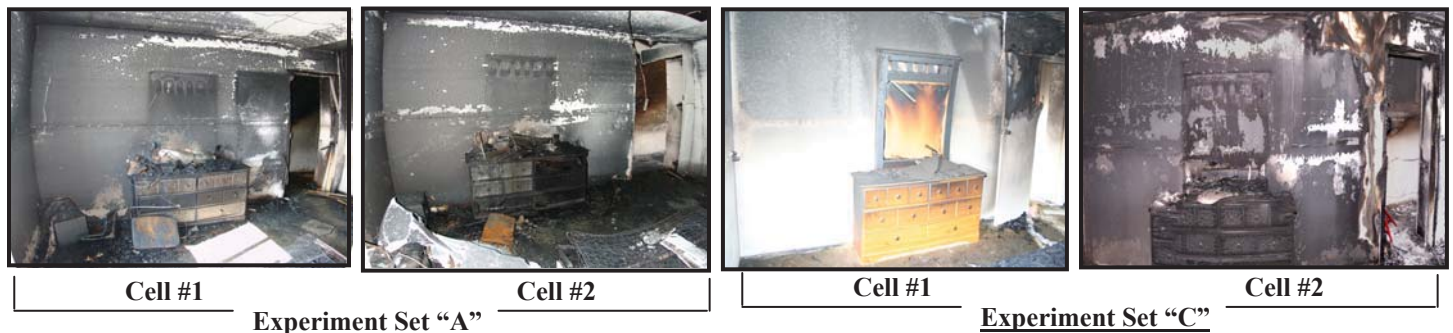
Figure 44-47 – West Wall (left to right) Exp. Set “A”: Cell #1, Cell #2; Exp. Set “C”: Cell #1, Cell #2

The patterns remaining on the west wall of the bedroom in all four experiments show good consistency (Figures 44-47). For example, protected area patterns remain on the west wall in the pre-fire location of the door and mirror for all four experiments.

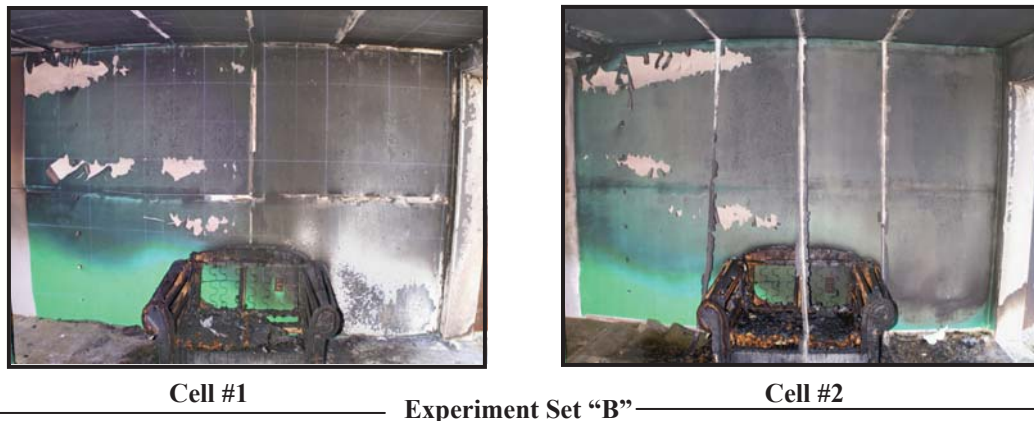
Figure 48-49 – Experiment Set “B”: West Wall - Cell #1 (left); Cell #2 (right)

Experiment set “B” (experiments #3 and #4) demonstrated remarkable similarity of the fire patterns. The loss of material patterns for the couch, loveseat, and end tables were almost identical (Figures 48-55). The ventilation patterns near the doorway were similar (Figures 48 and 49). The demarcation lines on the west wall corresponding to the airflow over the loveseat were nearly exact (Figures 48 and 49).

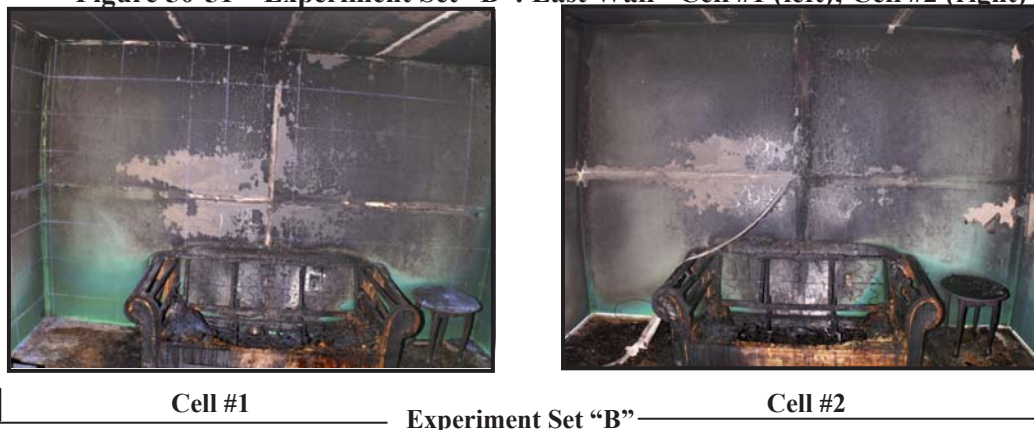
Figure 50-51 – Experiment Set “B”: East Wall - Cell #1 (left); Cell #2 (right)

Located on the east wall above the couch, a conical-shaped plume pattern existed in almost exact appearance between the two experiments (Figures 50 and 51). In fact, an almost perfect reproduction of the area of clean burn remained on each wall behind the couch.

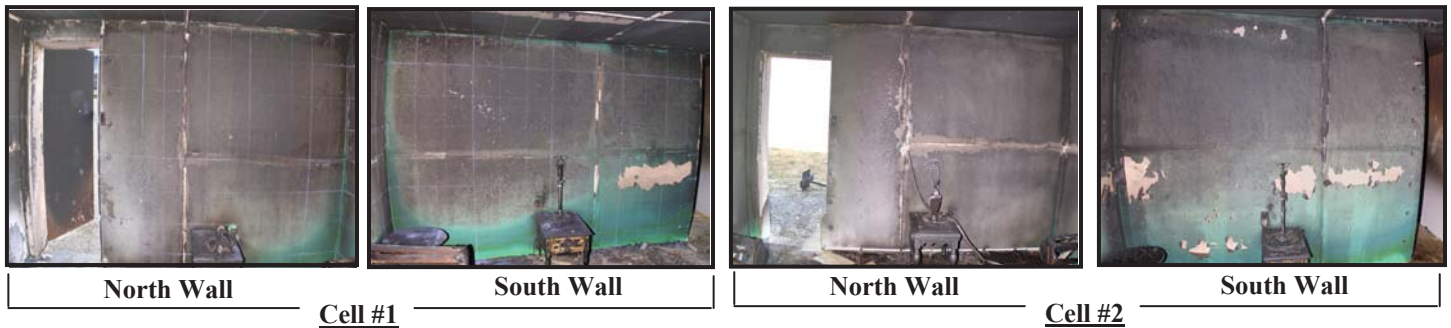
Figure 52-55 – Experiment Set “B”: (left to right) Cell #1; Cell #2

The remaining walls had similar truncated cone patterns, which originated from the plume on the couch (Figures 52-55).
