VEHICLE FIRE BURN PATTERN STUDY

Part 2

Nicholas J. Smith, BS, CFEI, CVFI, IAAI-CFI
ACS Investigative Services, Inc (USA)

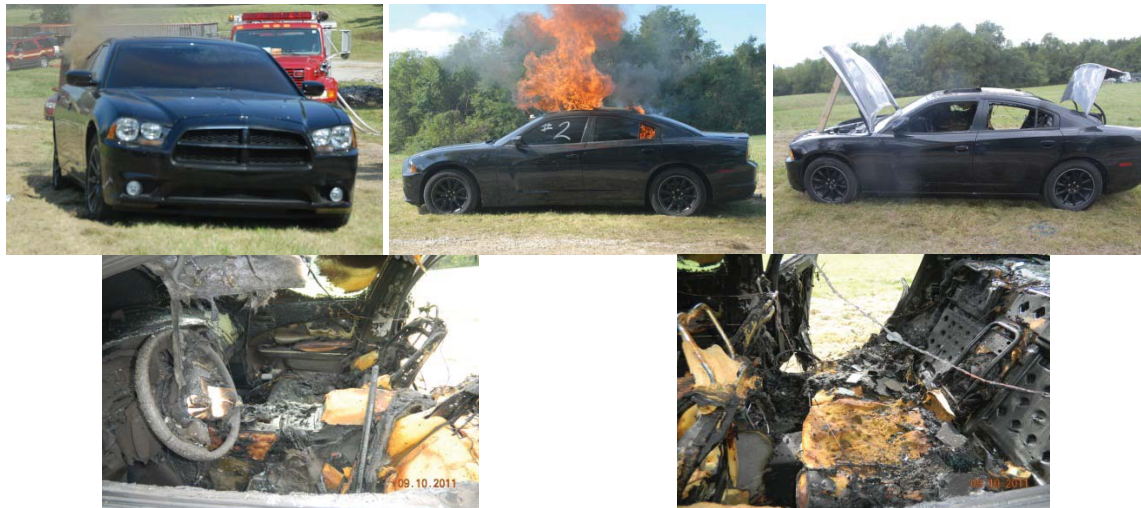
Figure 1-2009 Dodge Charger

In this first set of test burns, two similar vehicles were utilized, a 2009 Dodge Chargers (Figure 1) and a 2011 Dodge Charger (Figure 2). Both of these vehicles were ignited by a propane torch in the rear passenger compartment just behind the center console. Similar fire patterns were found within both of these vehicles indicating an interior compartment fire origin. These patterns included the following. The windshields started to fail at the top first as evidenced by the extensive oxidation and the cracking of the glass along the top frame. There was minor heat damage in the engine compartment indicating that the fire origins were not in the engine compartment. The elevation of oxidation damage along the roof and the A & B posts indicate that fire progressed from the interior to the exterior of the vehicles. The rear passenger areas sustained more fire damage than the front driver and passenger area, which indicated that the fire was toward the interior rear of the vehicle.

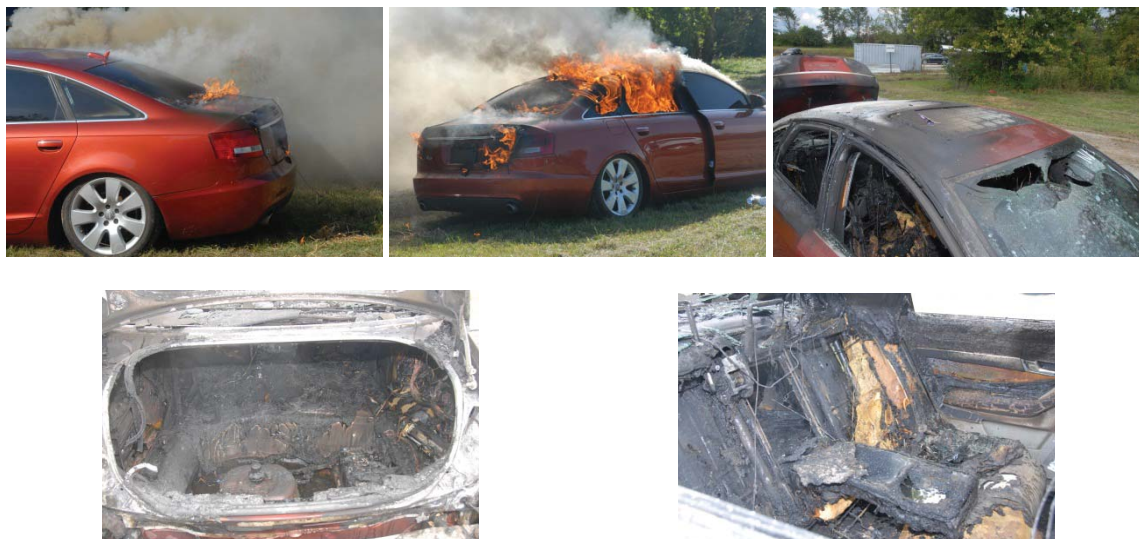
Figure 5-2006 Audi A6

In this third set of test burns, two similar vehicles were utilized, a 2006 Audi A6 (Figure 5) and a 2005 Audi A6 (Figure 6). Both of these vehicles were ignited by a propane torch in the storage compartment. Hay and paper was used to help fuel the fire. Fire patterns within these vehicles show that the fire originated in the cargo compartment. These patterns included the following. Consumption of furniture material the interior show more fire damage to the rear passenger compartment than to the front passenger compartment. Oxidation patterns indicate that fire progressed from the cargo compartment to the interior passenger compartment. The back window started to fail at the top, indicating a fire progressed into the passenger compartment. The cargo compartment sustained the area of most mass loss. Both vehicles had the greatest degree of oxidation to the cargo area. Based on these observations found, the area of fire origins of these vehicles was in the cargo compartment.

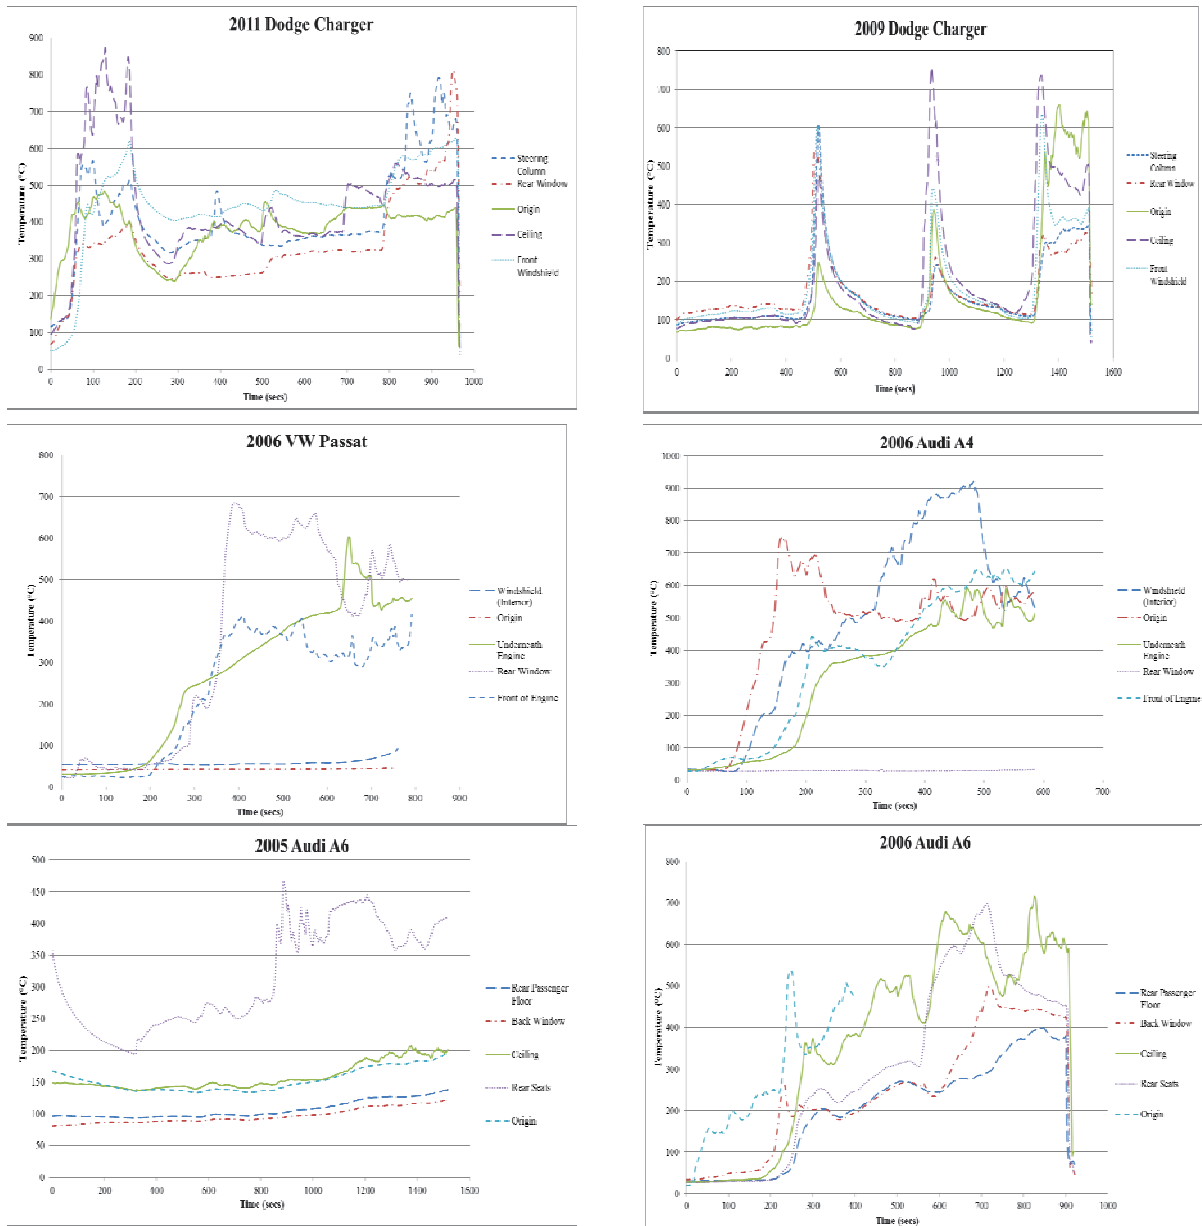
Figure 7-Thermocouple Data For Experiment Sets 1-3

Thermocouples were placed in various locations in each experimental sets of vehicles, and this data is provided at the end of this paper as Figure 12. These locations, which are listed specifically in the results section of each burn, included steering wheel, front of dashboard, interior roof, rear window and at the point of ignition. Additionally, temperature data was collected from bulk heads and compartment separation points as required by the scenario of the burn. This data was collected in excel spreadsheets which are represented in this paper as line graphs.
